**Flood Control Project Maintenance
Levee Inspections**

Maintenance Issue Types Only, Levee Inspection Report By Mile - Spring 2015

Reclamation District No. 0785 Driver

Waterway	Bank	Unit Miles	Inspection Start/End	Inspector
Unit No. 01 Sacramento River	Right	2.26	04/14/2015 04/14/2015	Jai Lor

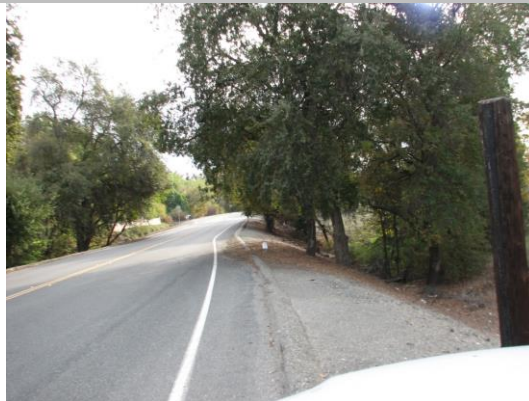
Photo 1 of 1 : SP_2015_RD0785_185_14_20150401_00011.jpg

LM Start	0.00	Rating **	A/W	Issue No.	14
LM End	2.31	Issue Type +	Ma	Location *	LS
Category	Earthen Levee			GPS Latitude/Longitude	
				Start	End
Item	Vegetation				°
					°
DWR ID	DWR_RD0785_01_f_2014_14				
Action/Comments					
Control annual grass and weeds on the levee slopes and easements.

Levee mile 0.00, vegetation on the land side slope. Fall 2014.

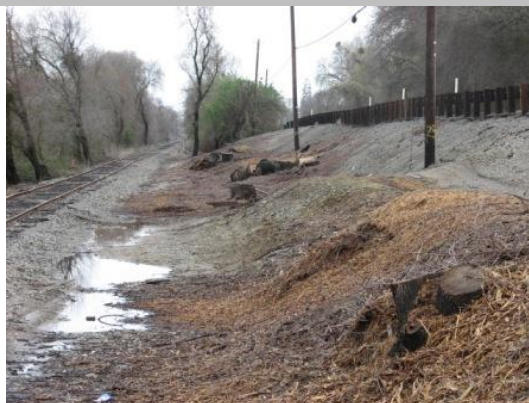
Photo 1 of 1 : SP_2015_RD0785_185_4_20150401_00003.jpg

LM Start	0.12	Rating **	N	Issue No.	4
LM End	1.34	Issue Type +	Ma	Location *	LS
Category	Earthen Levee			GPS Latitude/Longitude	
				Start	End
Item	Trim / Thin Trees			38.660160 °	38.646214 °
				-121.611619 °	-121.598596 °
DWR ID	DWR_RD0785_01_s_2012_4				
Action/Comments					
Tree stumps.

The trees were cut by PG&E'S tree contractor. The district will take care of the stumps in the future.

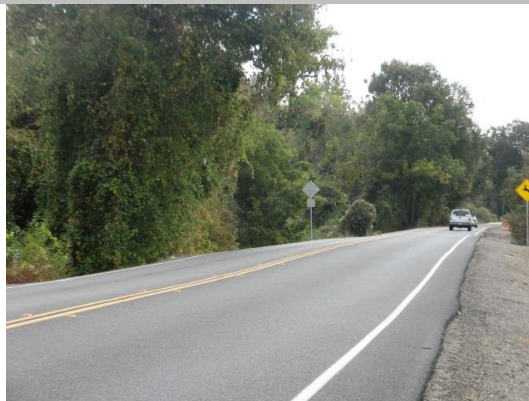
Photo 1 of 2 : SP_2015_RD0785_185_16_20150401_00012.jpg

LM Start	0.21	Rating **	M	Issue No.	16
LM End	1.35	Issue Type +	Ma	Location *	WS
Category	Earthen Levee			GPS Latitude/Longitude	
				Start	End
Item	Vegetation			38.659340 °	38.646093 °
				-121.610405 °	-121.598518 °
DWR ID	DWR_RD0785_01_f_2013_16				
Action/Comments					
Remove the wild growth other than native grasses from the levee slopes.

Brush and other vegetation partially blocks visibility or access to the levee slope. Fall 2013

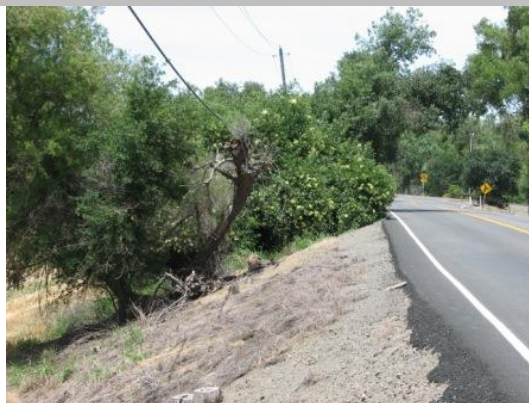
Photo 1 of 1 : SP_2015_RD0785_185_1_20150401_00001.jpg

LM Start	0.28	Rating **	A/W	Issue No.	1
LM End	0.28	Issue Type +	Ma	Location *	LS
Category	Earthen Levee			GPS Latitude/Longitude	
				Start	End
Item	Vegetation			38.658467 °	38.658467 °
				-121.609573 °	-121.609573 °
DWR ID	DWR_RD0785_01_s_2012_1				
Action/Comments					
Elderberries are blocking visibility and flood fight capability.

Elderberry

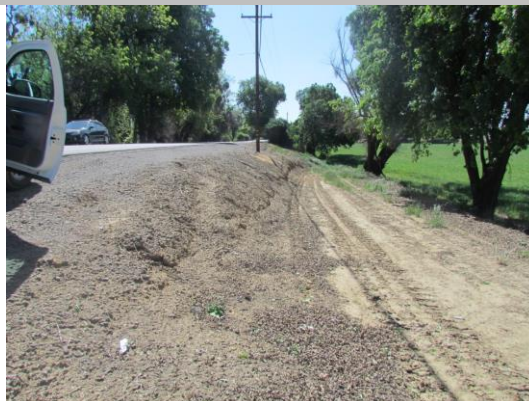
Photo 1 of 1 : SP_2015_RD0785_185_349_20150417_00024.jpg

LM Start	0.34	Rating **	M	Issue No.	349
LM End	0.34	Issue Type +	Ma	Location *	LS
Category	Earthen Levee			GPS Latitude/Longitude	
				Start	End
Item	Slope Stability			38.657798 °	38.657798 °
				-121.608898 °	-121.608898 °
DWR ID	DWR_RD0785_01_s_2015_349				
Action/Comments					
Repair slope instability.

View of the slope stability on the landward side of the levee looking downstream. Spring 2015.

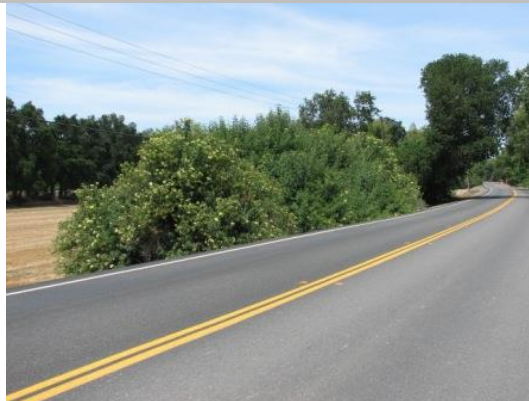
Photo 1 of 1 : SP_2015_RD0785_185_2_20150401_00002.jpg

LM Start	0.40	Rating **	A/W	Issue No.	2
LM End	0.44	Issue Type +	Ma	Location *	LS
Category	Earthen Levee			GPS Latitude/Longitude	
				Start	End
Item	Vegetation			38.657168 °	38.656697 °
				-121.608270 °	-121.607845 °
DWR ID	DWR_RD0785_01_s _ 2012_2				
Action/Comments					
Elderberries are blocking visibility and flood fight capability.

Elderberry

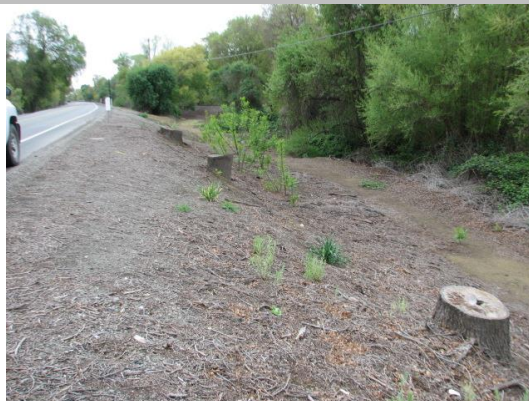
Photo 1 of 1 : SP_2015_RD0785_185_181_20150401_00019.jpg

LM Start	0.76	Rating **	N	Issue No.	181
LM End	0.76	Issue Type +	Ma	Location *	LS
Category	Earthen Levee			GPS Latitude/Longitude	
				Start	End
Item	Trim / Thin Trees			38.653003 °	38.653003 °
				-121.605061 °	-121.605061 °
DWR ID	DWR_RD0785_01_s _ 2014_181				
Action/Comments					
Tree stumps.

Tree stumps along the landside shoulder of the levee. Spring 2014

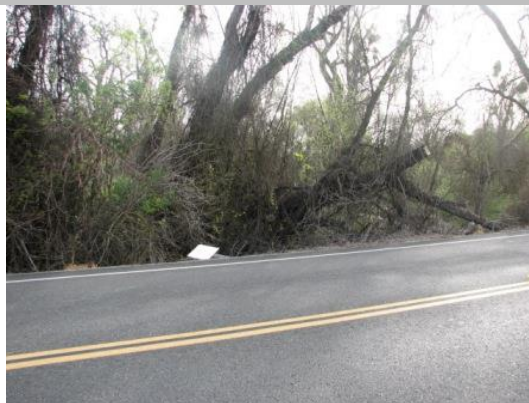
Photo 1 of 1 : SP_2015_RD0785_185_47_20150401_00015.jpg

LM Start	0.92	Rating **	M	Issue No.	47
LM End	0.92	Issue Type +	Ma	Location *	WS
Category	Earthen Levee			GPS Latitude/Longitude	
				Start	End
Item	Trim / Thin Trees			38.650992 °	38.650992 °
				-121.603392 °	-121.603392 °
DWR ID	DWR_RD0785_01_s_2012_47				
Action/Comments					
Trim and thin trees to allow visibility of the ground and room to flood fight.

The fallen tree and brush on the waterside of the roadway needs to be removed. Photo taken spring 2012.

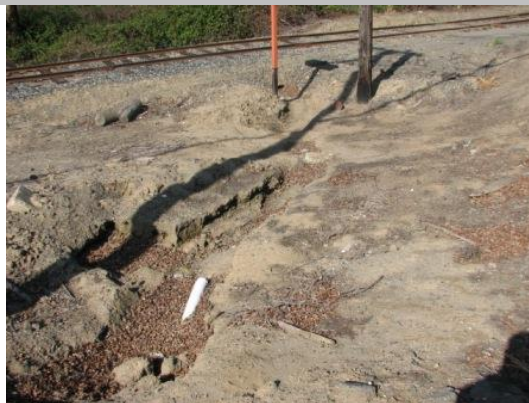
Photo 1 of 3 : SP_2015_RD0785_185_48_20150401_00016.jpg

LM Start	1.07	Rating **	M	Issue No.	48
LM End	1.07	Issue Type +	Ma	Location *	LS
Category	Earthen Levee			GPS Latitude/Longitude	
				Start	End
Item	Erosion / Bank Caving			38.649292 °	38.649292 °
				-121.601647 °	-121.601647 °
DWR ID	DWR_RD0785_01_s_2012_48				
Action/Comments					
Schedule repair of erosion site prior to the next inspection.

The drain pipe across from the firehouse has caused erosion, photo taken spring 2012.

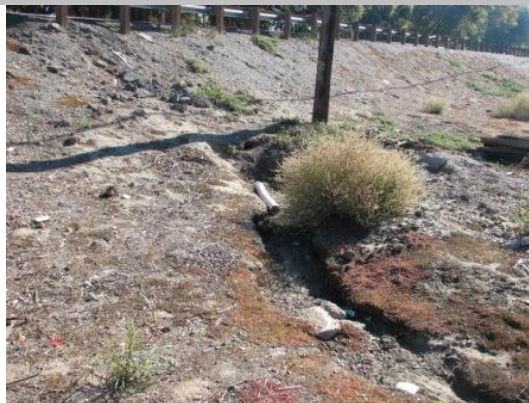
Photo 2 of 3 : SP_2015_RD0785_185_48_20150401_00017.jpg

LM Start	1.07	Rating **	M	Issue No.	48 (cont)
LM End	1.07	Issue Type +	Ma	Location *	LS
Category	Earthen Levee			GPS Latitude/Longitude	
				Start	End
Item	Erosion / Bank Caving			38.649292 °	38.649292 °
				-121.601647 °	-121.601647 °
DWR ID	DWR_RD0785_01_s_2012_48				
Action/Comments					
Schedule repair of erosion site prior to the next inspection.

Erosion on the levee slope and toe. Fall 2012

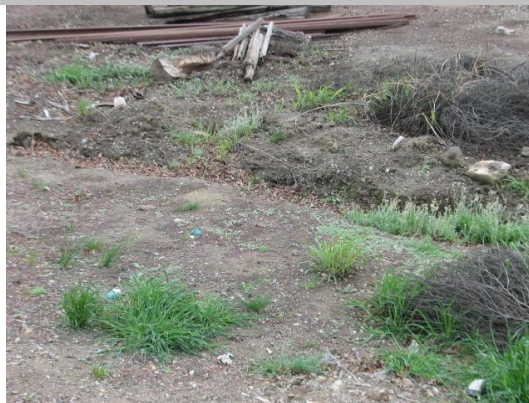
Photo 3 of 3 : SP_2015_RD0785_185_48_20150401_00018.jpg

Drain pipe is causing erosion on the landside of the levee between the slope and railroad tracks. Spring 2014

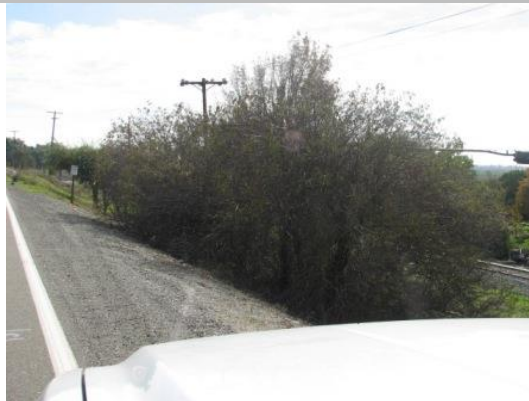
Photo 1 of 1 : SP_2015_RD0785_185_6_20150401_00004.jpg

LM Start	1.30	Rating **	A/W	Issue No.	6
LM End	1.30	Issue Type +	Ma	Location *	LS
Category	Earthen Levee			GPS Latitude/Longitude	
				Start	End
Item	Vegetation			38.646712 °	38.646712 °
				-121.599095 °	-121.599095 °
DWR ID	DWR_RD0785_01_s_2012_6				
Action/Comments					
Elderberries are blocking visibility and flood fight capability.

This is a very large Elderberry bush.

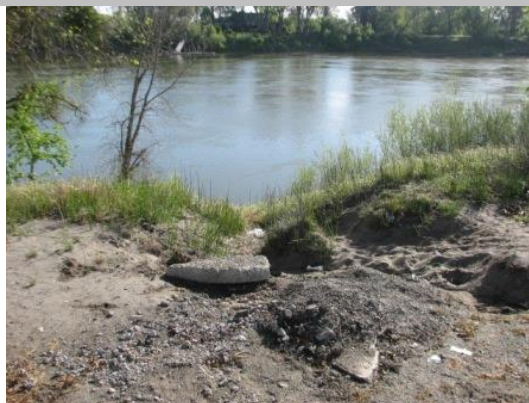
Photo 1 of 2 : SP_2015_RD0785_185_13_20150401_00009.jpg

LM Start	1.31	Rating **	M	Issue No.	13
LM End	1.31	Issue Type +	Ma	Location *	WS
Category	Earthen Levee			GPS Latitude/Longitude	
				Start	End
Item	Erosion / Bank Caving			38.646671 °	38.646671 °
				-121.598915 °	-121.598915 °
DWR ID	DWR_RD0785_01_s_2013_13				
Action/Comments					
Schedule repair of erosion site prior to the next inspection.

The erosion has become a trail for fishermen and contributes to it. Spring 2013

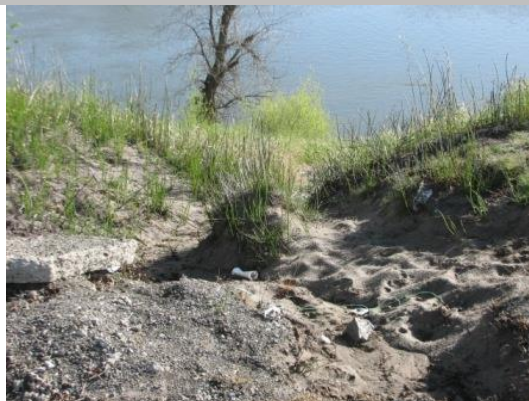
Photo 2 of 2 : SP_2015_RD0785_185_13_20150401_00010.jpg

The waterside levee slope has erosion from surface run off. Spring 2013

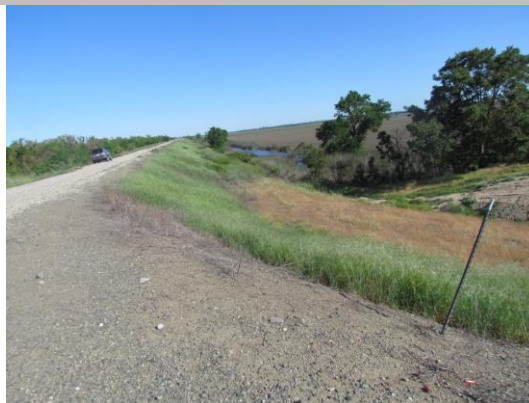
Photo 1 of 1 : SP_2015_RD0785_186_2_20150417_00018.jpg

LM Start	0.00	Rating **	A/W	Issue No.	2		
LM End	3.30	Issue Type +	Ma	Location *	LS		
Category	Earthen Levee			GPS Latitude/Longitude			
				Start		End	
Item	Vegetation				°		°
					°		°
DWR ID	DWR_RD0785_02_f_2014_2						
Action/Comments							
Control annual grass and weeds on the levee slopes and easements.

View of the vegetation on the landward side of the levee looking upstream. Spring 2015.

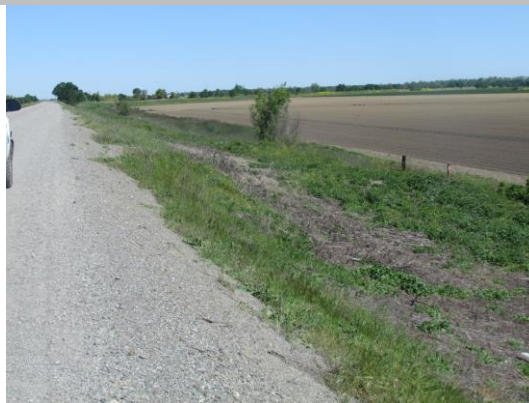
Photo 1 of 1 : SP_2015_RD0785_186_280_20150417_00019.jpg

LM Start	0.38	Rating **	M	Issue No.	280
LM End	0.38	Issue Type +	Ma	Location *	LS
Category	Earthen Levee			GPS Latitude/Longitude	
				Start	End
Item	Slope Stability			38.636265 °	38.636265 °
				-121.617422 °	-121.617422 °
DWR ID	DWR_RD0785_02_s_2015_280				
Action/Comments					
Repair slope instability.

View of the slope stability on the landward side of the levee looking upstream. Spring 2015.

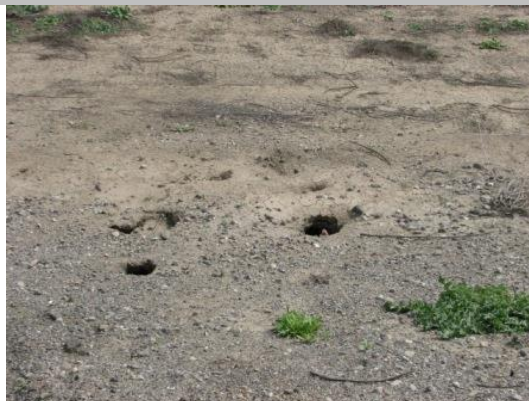
Photo 1 of 1 : SP_2015_RD0785_186_27_20150401_00004.jpg

LM Start	0.40	Rating **	A/W	Issue No.	27
LM End	0.40	Issue Type +	Ma	Location *	LS
Category	Earthen Levee			GPS Latitude/Longitude	
				Start	End
Item	Animal Control			38.636065 °	38.636065 °
				-121.617295 °	-121.617295 °
DWR ID	DWR_RD0785_02_s_2012_27				
Action/Comments					
No rodents visible, but rodent burrows visible; need to backfill and compact or grout burrows.					
Inspector Comments: Unable to see slope. Vegetation to tall to see.

Rodent holes on the landside levee slope, photo taken spring 2012.

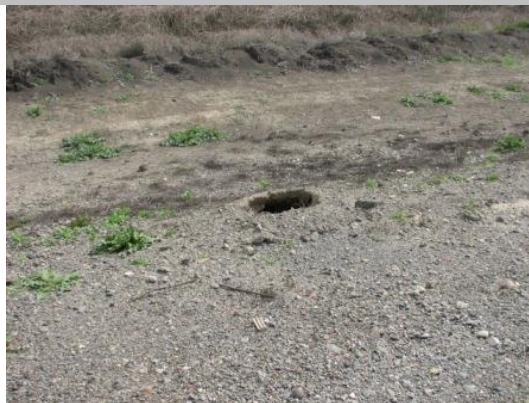
Photo 1 of 2 : SP_2015_RD0785_186_28_20150401_00005.jpg

LM Start	0.48	Rating **	A/W	Issue No.	28
LM End	0.48	Issue Type +	Ma	Location *	LS
Category	Earthen Levee			GPS Latitude/Longitude	
				Start	End
Item	Animal Control			38.634978 °	38.634978 °
				-121.616612 °	-121.616612 °
DWR ID	DWR_RD0785_02_s_2012_28				
Action/Comments					
No rodents visible, but rodent burrows visible; need to backfill and compact or grout burrows. Inspector Comments: Unable to see slope. Vegetation too tall to see.

Many rodent holes with in 25' of each other, photo taken spring 2012.

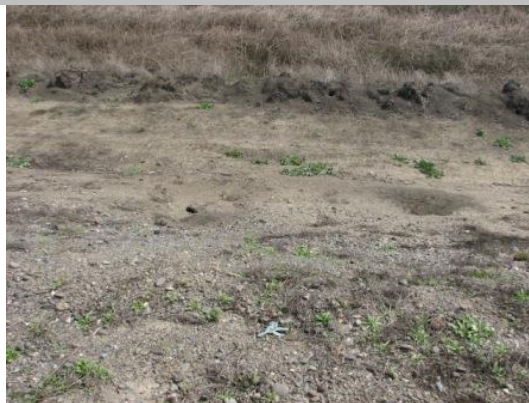
Photo 2 of 2 : SP_2015_RD0785_186_28_20150401_00006.jpg

Rodent holes on the landside levee slope, photo taken spring 2012.

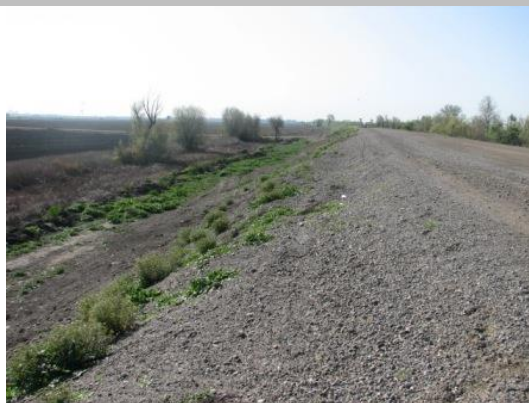
Photo 1 of 2 : SP_2015_RD0785_186_29_20150401_00007.jpg

LM Start	0.54	Rating **	M	Issue No.	29
LM End	0.54	Issue Type +	Ma	Location *	LS
Category	Earthen Levee			GPS Latitude/Longitude	
				Start	End
Item	Slope Stability			38.634180 °	38.634180 °
				-121.616142 °	-121.616142 °
DWR ID	DWR_RD0785_02_s_2012_29				
Action/Comments					
Repair slope instability.

Slope instability at shoulder of landside levee buldge at toe.

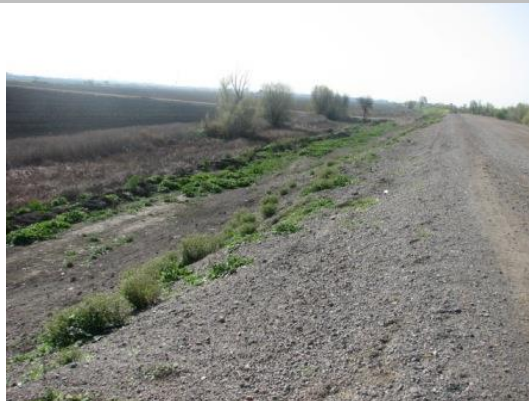
Photo 2 of 2 : SP_2015_RD0785_186_29_20150401_00008.jpg

LM Start	0.54	Rating **	M	Issue No.	29 (cont)	
LM End	0.54	Issue Type +	Ma	Location *	LS	
Category	Earthen Levee			GPS Latitude/Longitude		
				Start		End
Item	Slope Stability			38.634180 °		38.634180 °
				-121.616142 °		-121.616142 °
DWR ID	DWR_RD0785_02_s _ 2012_29					
Action/Comments						
Repair slope instability.

Bulge at the landside toe of the levee, photos taken spring 2012.

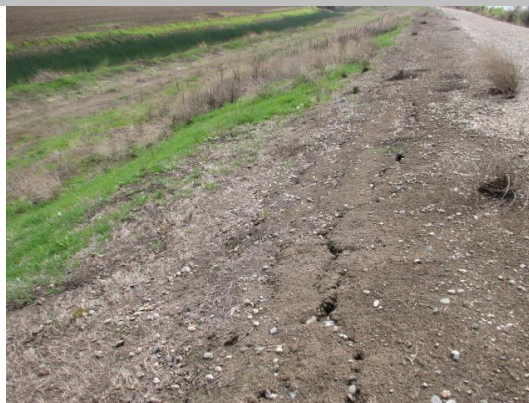
Photo 1 of 1 : SP_2015_RD0785_186_143_20150401_00015.jpg

LM Start	0.88	Rating **	M	Issue No.	143
LM End	0.88	Issue Type +	Ma	Location *	LS
Category	Earthen Levee			GPS Latitude/Longitude	
				Start	End
Item	Slope Stability			38.629693 °	38.629693 °
				-121.613436 °	-121.613436 °
DWR ID	DWR_RD0785_02_s _ 2014_143				
Action/Comments					
Repair slope instability.

Cracking along the shoulder causing slope instability. Spring 2014

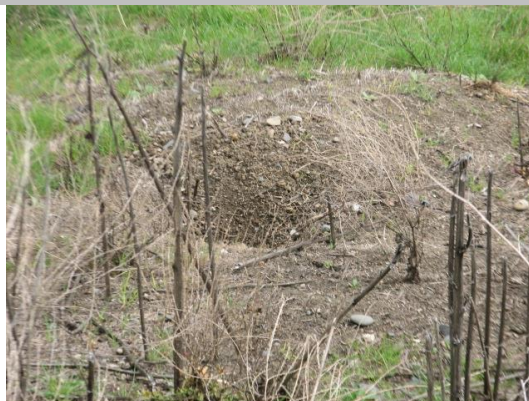
Photo 1 of 1 : SP_2015_RD0785_186_42_20150401_00013.jpg

LM Start	0.89	Rating **	M	Issue No.	42
LM End	0.92	Issue Type +	Ma	Location *	LS
Category	Earthen Levee			GPS Latitude/Longitude	
				Start	End
Item	Animal Control			38.629589 °	38.629259 °
				-121.613372 °	-121.613156 °
DWR ID	DWR_RD0785_02_s _ 2014_42				
Action/Comments					
No rodents visible, but rodent burrows visible; need to backfill and compact or grout burrows.

Large rodent hole close to the toe of the levee. Spring 2014

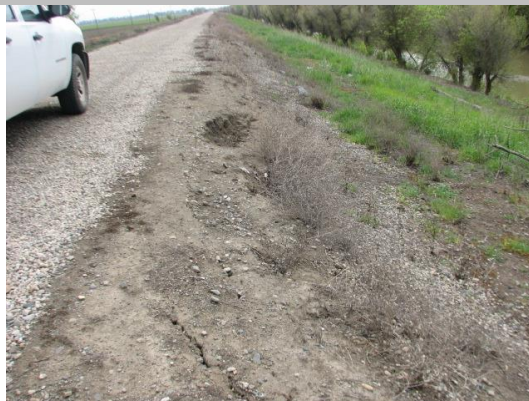
Photo 1 of 1 : SP_2015_RD0785_186_144_20150401_00016.jpg

LM Start	1.12	Rating **	M	Issue No.	144
LM End	1.12	Issue Type +	Ma	Location *	WS
Category	Earthen Levee			GPS Latitude/Longitude	
				Start	End
Item	Slope Stability			38.626676 °	38.626676 °
				-121.611325 °	-121.611325 °
DWR ID	DWR_RD0785_02_s_2014_144				
Action/Comments					
Repair slope instability.

Slope instability along the waterside shoulder. Spring 2014

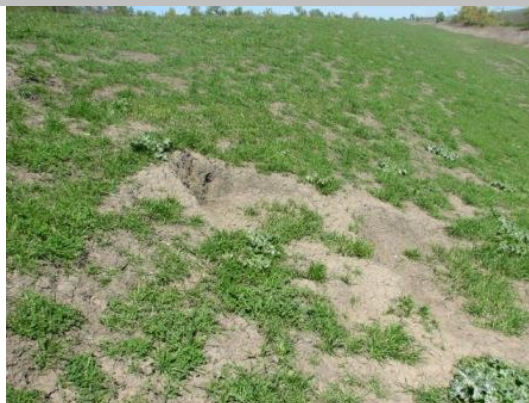
Photo 1 of 4 : SP_2015_RD0785_186_30_20150401_00009.jpg

LM Start	2.21	Rating **	M	Issue No.	30
LM End	2.21	Issue Type +	Ma	Location *	LS
Category	Earthen Levee			GPS Latitude/Longitude	
				Start	End
Item	Slope Stability			38.613104 °	38.613104 °
				-121.600915 °	-121.600915 °
DWR ID	DWR_RD0785_02_s_2012_30				
Action/Comments					
Repair slope instability.

There is slope instability with three step like spots. The cuts are 1' to 1.5' deep. Photo taken spring 2012.

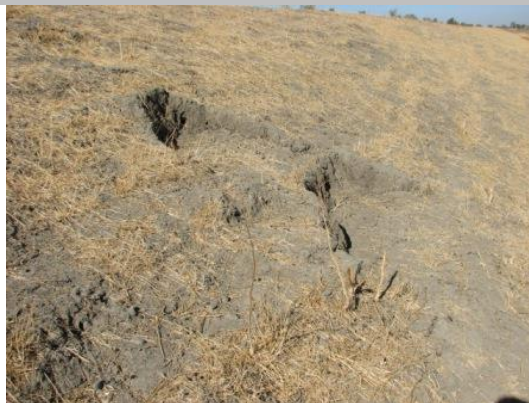
Photo 2 of 4 : SP_2015_RD0785_186_30_20150401_00010.jpg

Slope instability. Photo fall 2012.

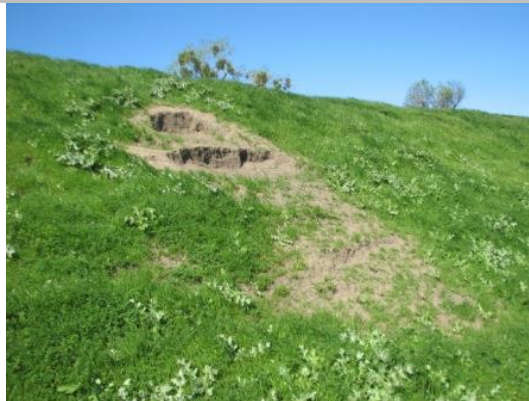
Photo 3 of 4 : SP_2015_RD0785_186_30_20150401_00011.jpg

LM Start	2.21	Rating **	M	Issue No.	30 (cont)
LM End	2.21	Issue Type +	Ma	Location *	LS
Category	Earthen Levee			GPS Latitude/Longitude	
				Start	End
Item	Slope Stability			38.613104 °	38.613104 °
				-121.600915 °	-121.600915 °
DWR ID	DWR_RD0785_02_s_2012_30				
Action/Comments					
Repair slope instability.

Slope instability is still there. Spring 2013

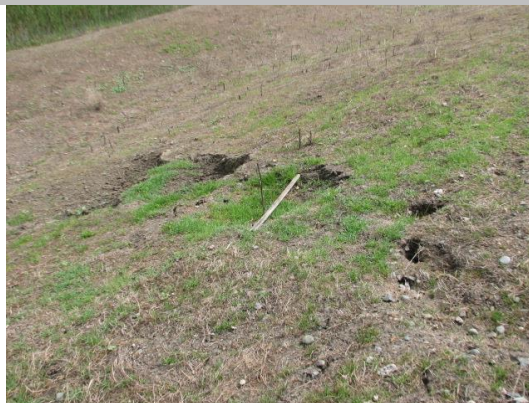
Photo 4 of 4 : SP_2015_RD0785_186_30_20150401_00012.jpg

Current view of the slope instability. Spring 2014
